Rockslide Blocks Traffic

Boulders blockaded Route 5 in Bamet after two large rockslides Wednesday morning.

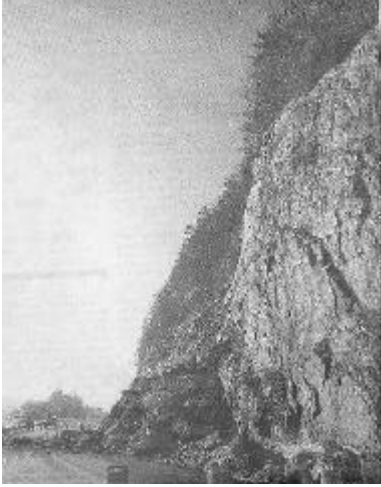
The slides occurred about a mile south of Comerford Dam Road, where Route 5 runs between north- and southbound Interstate 91.

Currently, the rock face is very unstable and more slides are expected, said Ken Leach, general maintenance supervisor for the Vermont Agency of Transportation.

A total of about 750 tons of rock crashed into the roadway, said Leach. The first slide happened around 1 a.m. and no one was injured. About eight to 10 transportation personnel cleaned up the debris and by 6:30 a.m. both lanes of travel were opened to motorists. At that time, Leach was convinced the scene was secure.

Later, a rock ledge shifted and Leach reclosed the road. Route 5 was barricaded just in time; rocks reshowered the roadway around 10 a.m. Some civilian vehicles were still in the area, but no one was injured and no cars were damaged, said Leach.

Route 5 was not gouged by the first slide. Whether the road was damaged in the second slide is unknown as boulders still cover the roadway. Leach does not want transportation workers to begin removing the debris until the rock face is made secure.

A cycle of freezes and thaws is the cause of most rockslides, said Leach. Water seeps into cracks and expands as it freezes. That pressure then dislodges chunks of rock.

Stabilization is the first step, said Leach. Crews rappel down the rock face and pry boulders loose with hand tools. If that doesn't work, inflatable bags are stuffed into cracks in the rocks. When the bags are filled, the air pressure dislodges the rocks. Those boulders are then smashed with large hydraulic hammers attached to excavators. Blasting is sometimes used to break up large rocks, but it's not likely to be used on Route 5, said Leach.

If all the loose rocks cannot be brought down, they can be pinned to the mother rock, said Leach.
